## Checkerplate Steel Floor

**Manufacturer:** Freecom, Inc.  
**Distributor:** Wear-Cor Solutions  
Edmonton, Alberta, Canada  
**Customer:** Lube City  
Edmonton, Alberta, Canada  
**Applicator:** Universal Coating Inc.

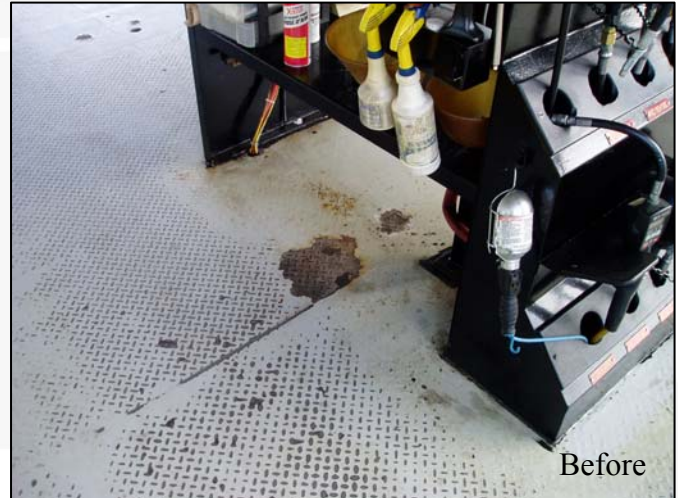
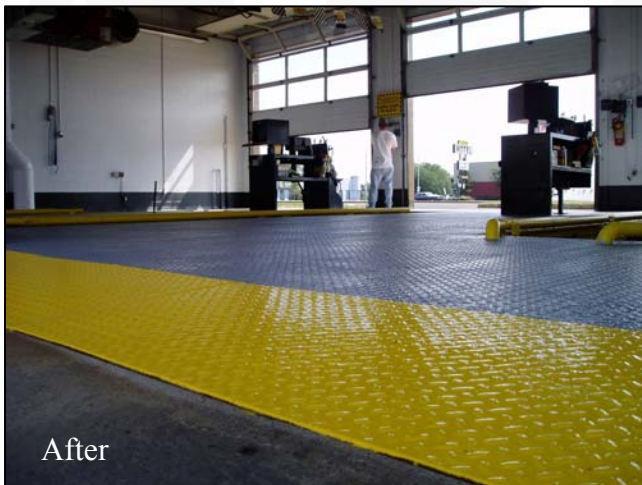
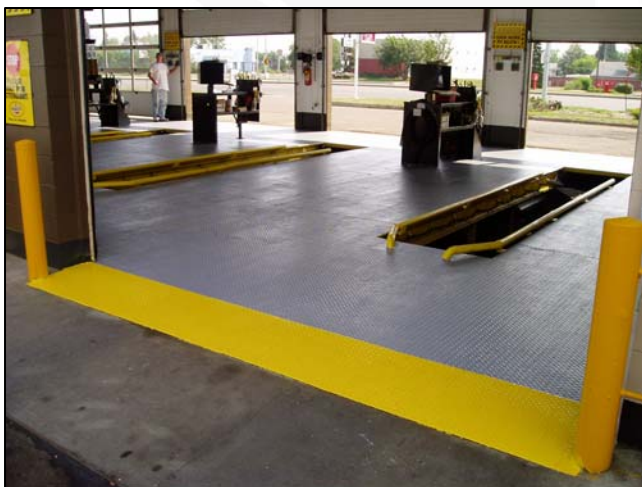
The customer had an epoxy applied to their checkerplate floor that showed signs of failure after 18 months of service. It was determined the coating was disbonding due to the flexibility of the substrate. The customer was looking for another coating that would last, offered better cosmetics, cleanability and an anti-skid surface.

CeRam-Kote 99M was suggested as a solution due to its flexibility and resistance to abrasion, corrosion and impact. CeRam-Kote 99M, which has a semi-gloss finish, also offers better cosmetics than most epoxies.

The customer's expectations were met with CeRam-Kote 99M. This application makes cleanability simple as the staff mop the floor to keep water from entering the underground work stations. An anti-skid media was applied to the un-cured coating prior to applying an additional topcoat. Mopheads last longer because the topcoat does not directly expose the abrasive anti-skid material.
