Kalahari Resort Waterslides

Manufacturer: Freecom, Inc.

Customer: Kalihari Resort
Wisconsin Dells, Wisconsin

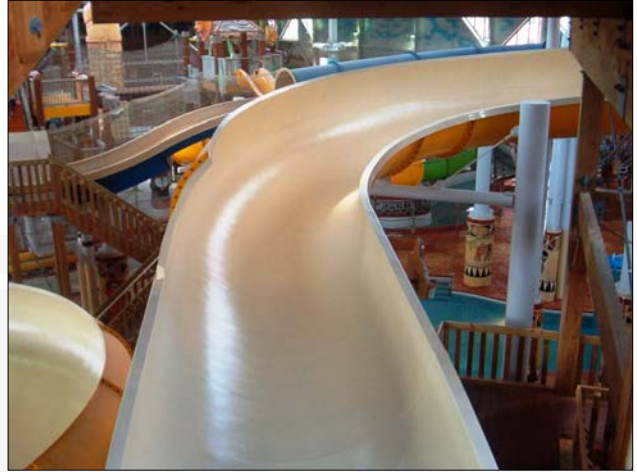
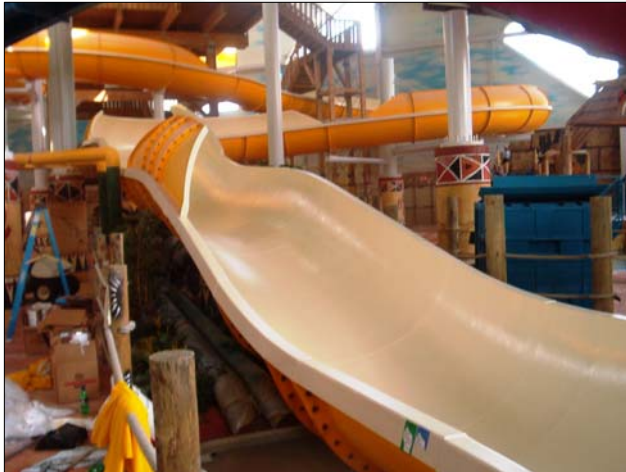
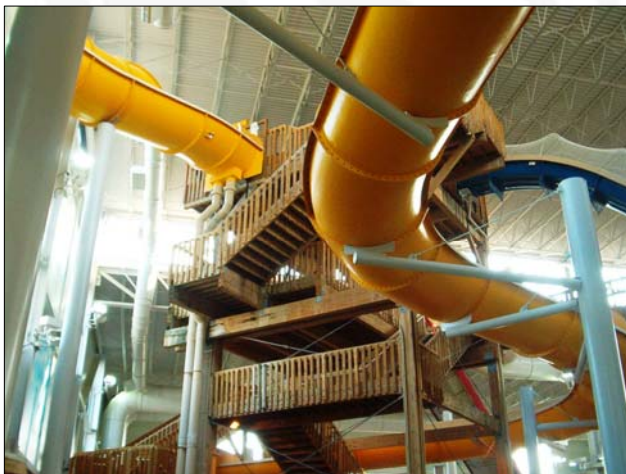
- Kalahari needed to refinish 2 waterslides that had worn gelcoat surfaces. The resort is open 365 days a year, so repair and recoating time was short.
- Employees were to be used to do the work

- Prep work was done at night for 3 weeks prior to the 4 day shut-down
- Slides were cleaned and wiped down after additional sanding was performed
- Mixing stations were set up at the base of the slides, coating mixed and taken up slides to paint crews who started at the top of the slides and worked down
- Slides were rolled, not sprayed due to overspray issues

- Paint crews were able to complete coating within timetable given to allow cure time prior to reopening of the water park
